The use of self compacting concrete in the rehabilitation of a jetty in Trafaria, Portugal

Julio APPLETON¹, António COSTA²

Abstract

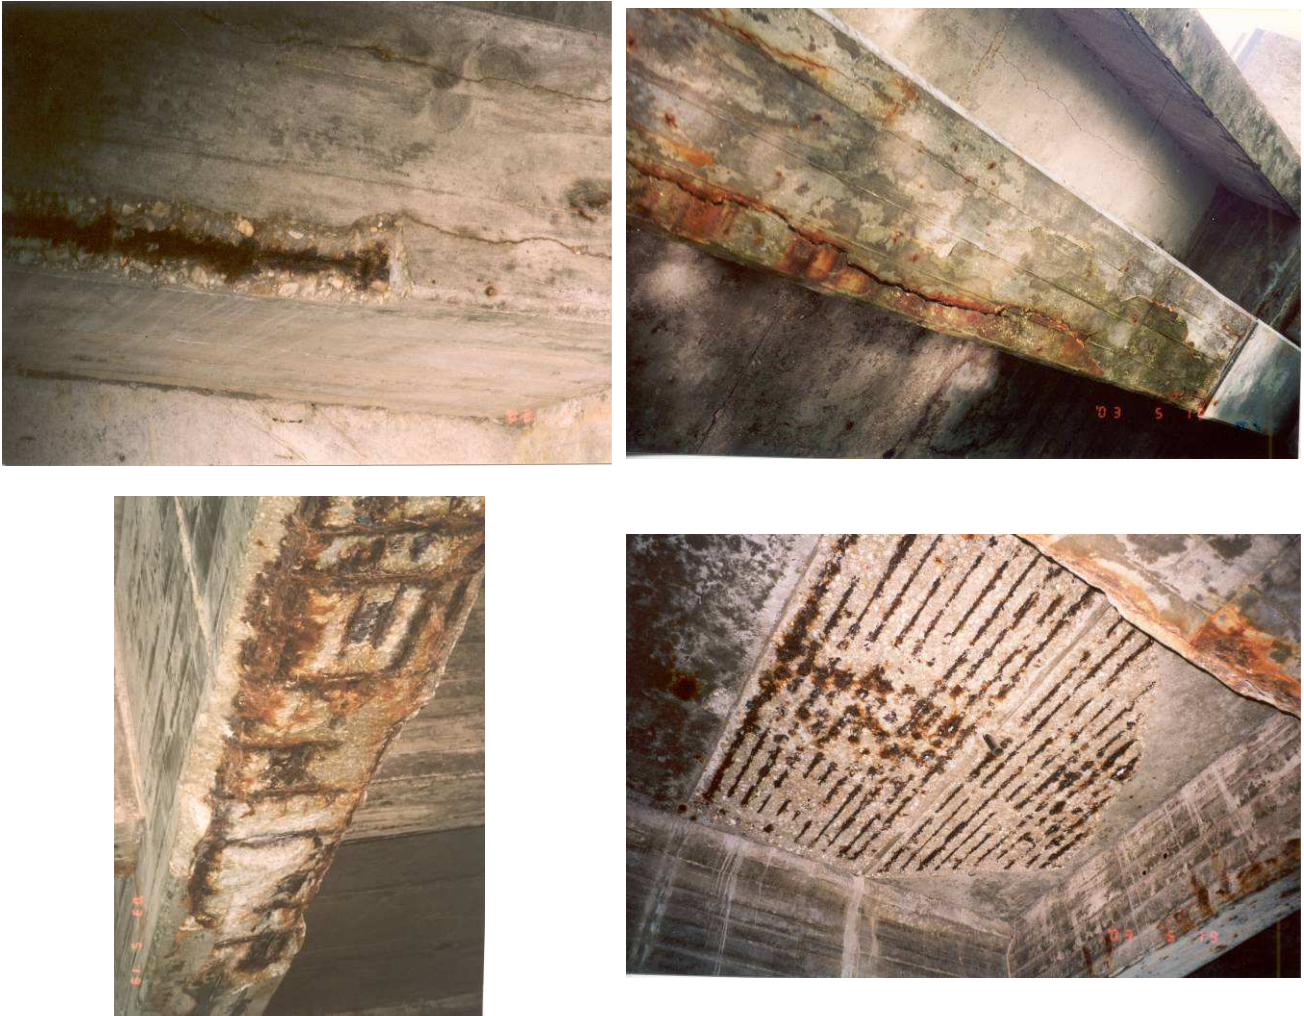
Fig. 3 Deterioration levels in 2004

- The reinforcement corrosion and the spalling in the main beams are much smaller than in the other beams. The high tide generally reaches the bottom of the main beams saturating them (and so the corrosion rate is reduced).

- In the secondary beams the corrosion is concentrated in the bottom face and corners. The concentration of reinforcement near the bottom of these simply supported beams increased the effects of expansion forces due to corrosion. These bottom faces are subjected to the "splash" zone and the high tide never reaches their level.

- The pre cast slab used to concrete the slab shows a generalised delamination.
This bottom slab face is subjected to very aggressive conditions. In winter the splash of the waves reaches its surface. In summer the evaporation, due to high temperatures, leads to the condensation of salted water and the consequent absorption of chlorides by concrete.

- The pedestrian beams were too slender. Delamination of concrete exposed the prestressed ducts and so its replacement was planned. Some days prior to their replacement, one of these beams collapsed into the river bed, subjected only to its dead weight and without any accidental effect.

The concrete cover showed a large scatter, between 17 to 62 mm. The critical chloride content ($\approx 0.4\%$ of the concrete mass) was reached up to 45 mm inside concrete, so in a significant part of the passive reinforcement corrosion was progressing.

- the replacement of the whole surface of the concrete cover by a new high performance micro-concrete and introduction of an epoxy surface protection. A minimum concrete cover of 50 mm was also specified;

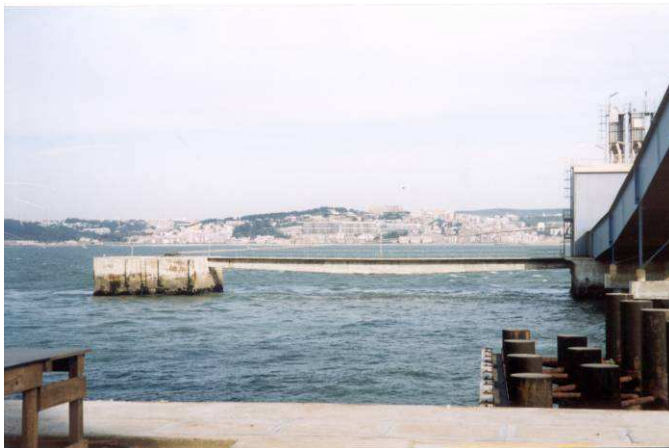
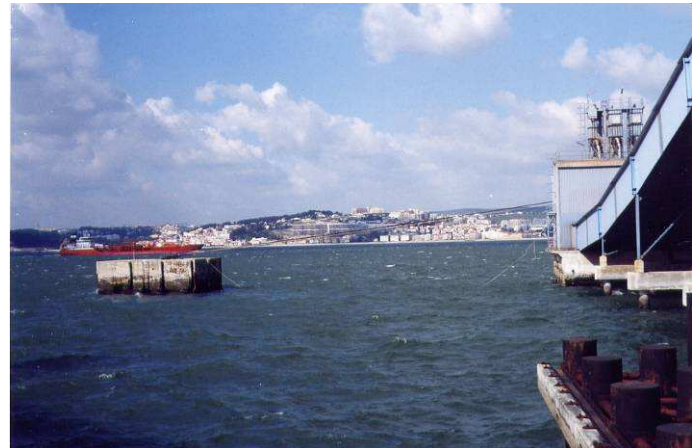
Fig. 6 Views of the pedestrian bridge

The underwater inspection showed that the collapse was due to the failure of the mid span in flexure. The inspection of the other two pedestrian bridges showed that the cement grout inside the duct was already contaminated by chlorides.

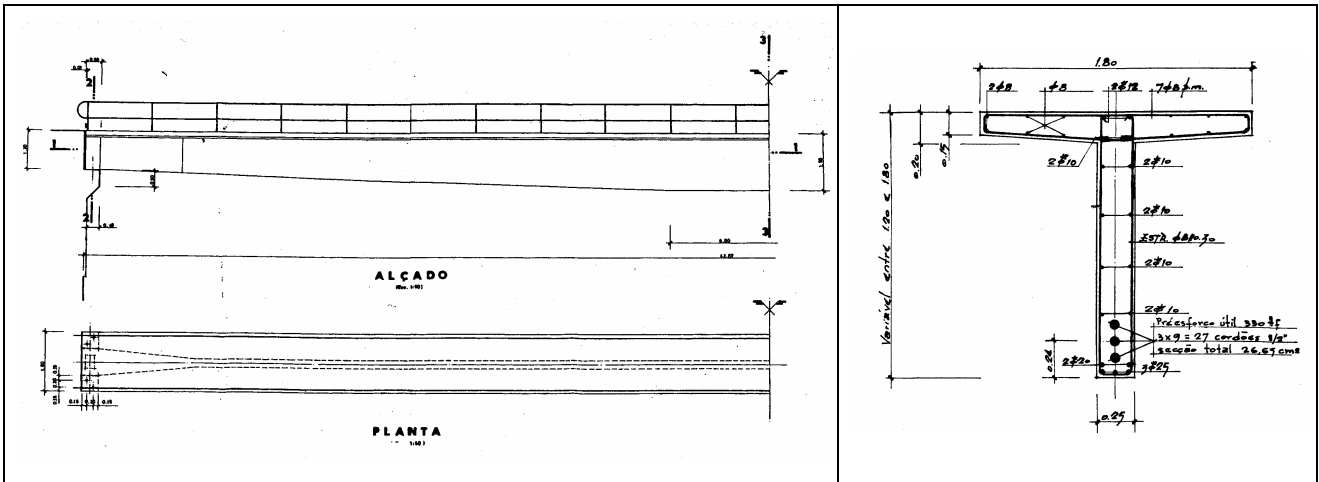
Fig. 7 Dimensions and characteristics of the collapsed bridge

The bending moment due to the dead load was 3970 kNm and the resistant bending moment was 7123 kNm.

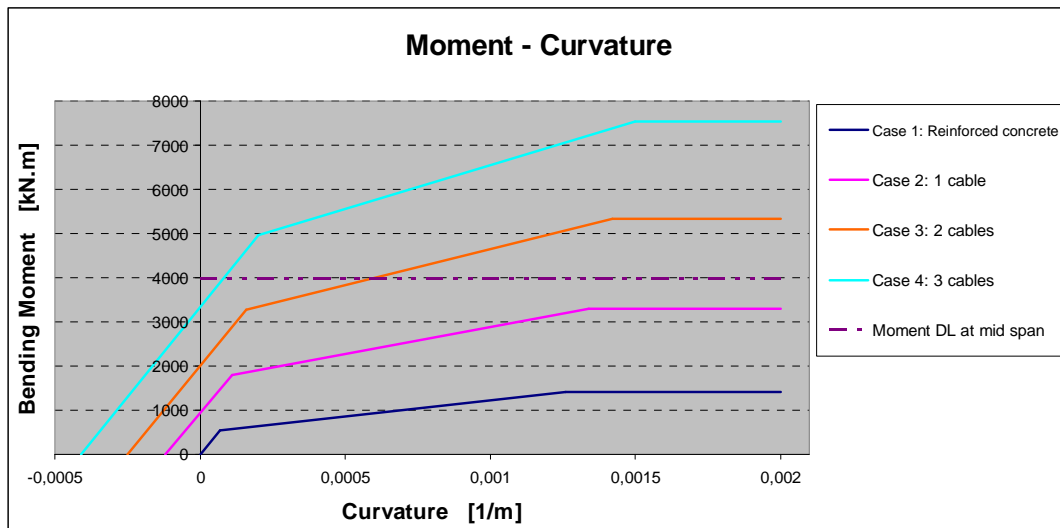
Fig. 8 Moment-curvature relations - assessment of collapse

The collapse occurred on the 24.02.2004 with the beam subjected only to its dead load. For the collapse to occur a minimum of 2 cables had to rupture, as shown in fig. 8.

The degree of prestressing was high and thus safety mainly relied in the prestressing cable resistance. A high amount of non active reinforcement is important for the robustness of such structures.
